MISCELLANEOUS PAPER CERC-86-8

STABILITY TEST OF MODIFIED REPAIR OPTIONS FOR SAN PEDRO BREAKWATER LOS ANGELES, CALIFORNIA

Coastal Model Investigation

R. Clay Baumgartner, Robert D. Carver,
D. Donald Davidson, Charles R. Herrington

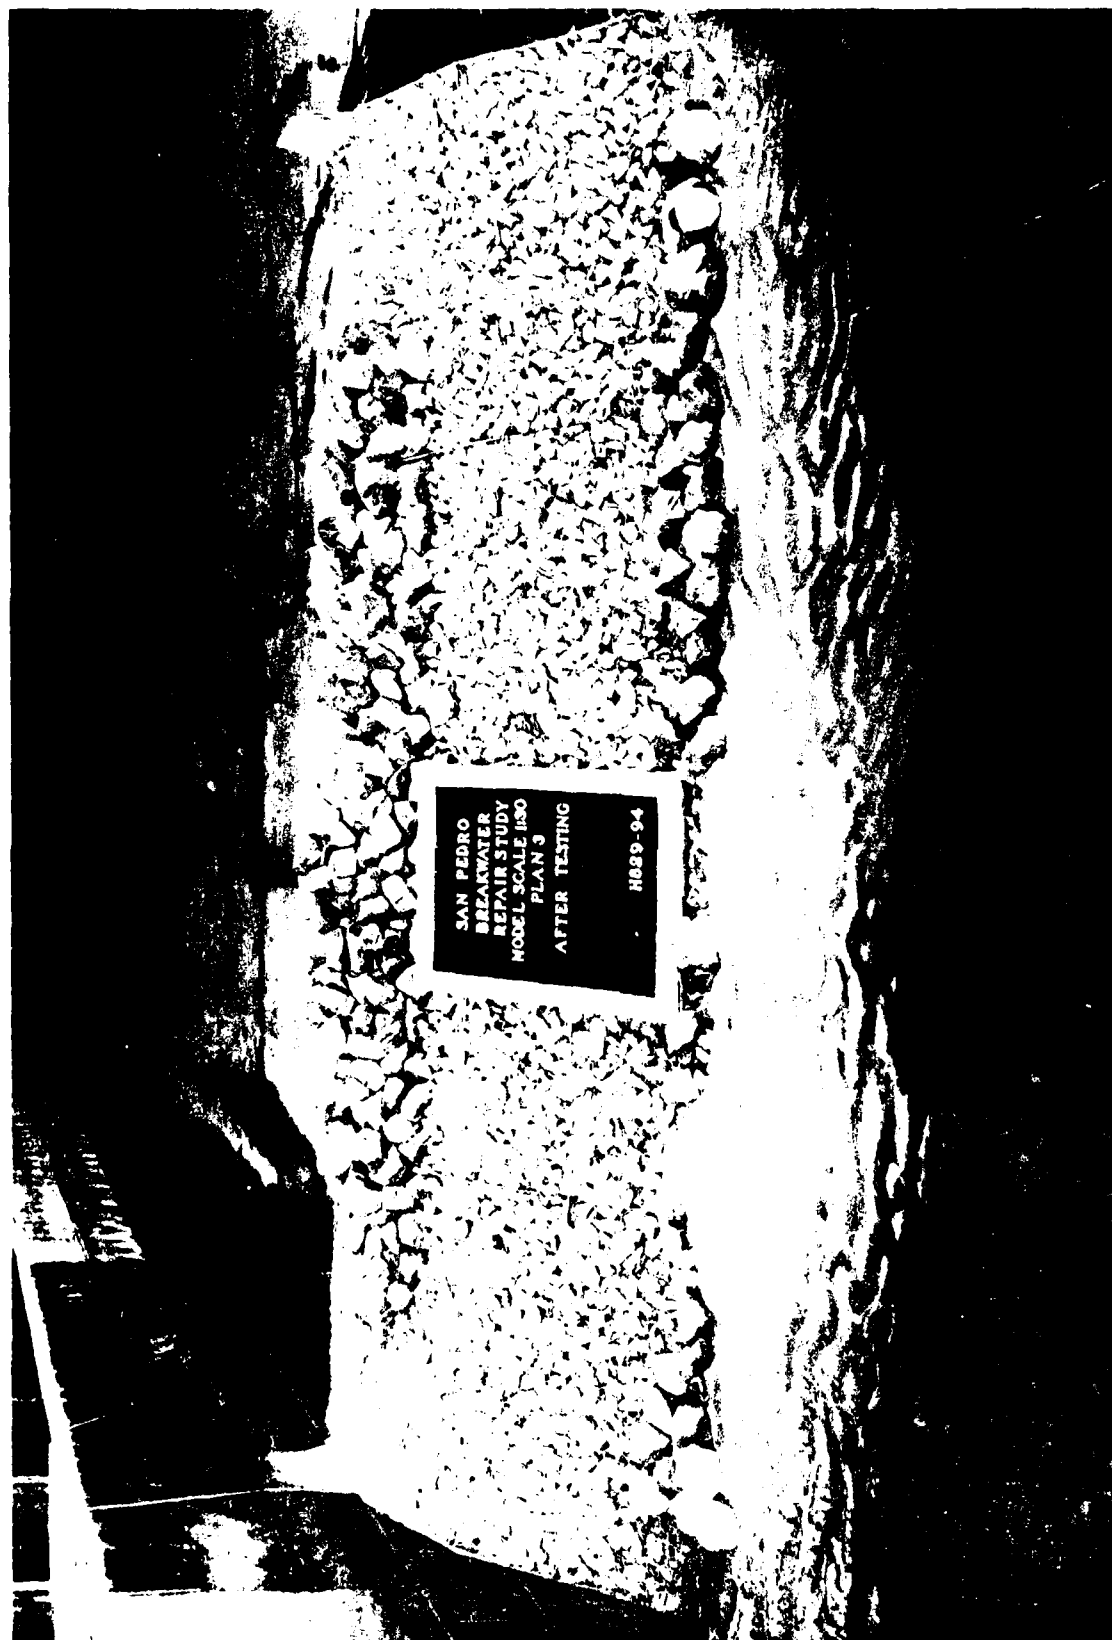
20. Plan 3 (Plate 6) was tested to determine its margin of safety for both wave directions 1 and 2. Safety factor tests (Table 2) of Plan 3 were initiated as an extension of Hydrograph B (Table 1). For wave direction 1, damage progressed throughout the safety factor tests; however, failure was not complete at the conclusion of tests (Photos 23 and 24). Damage was concentrated in two areas, near the transitions and the harbor side of the repair section. Wave overtopping caused displacement of the 7- to 20-ton stone on the harbor side of the structure with the largest amount of dislocation occurring during attack of 8-sec, 20-ft waves. Original granite blocks had

been displaced during Hydrograph B, leaving the stone in the transition areas without support and vulnerable to wave attack during safety factor tests. Damage from testing at wave direction 2 was concentrated on the harbor side of the repair section and was caused by wave overtopping. The 7- to 20-ton stone on the harbor side was displaced first, leaving the 13- to 20-ton stone on the sea side without support and vulnerable to wave attack. Damage became extensive for the 16-sec, 18-ft waves. Although an attempt was made to hold the original granite block sections in place for testing at wave direction 2, some granite block was displaced in the transition areas. Again, failure of the repair section was not complete at the conclusion of tests (Photos 25 and 26).

Photo 23. Sea-side view of Plan 3 after factor of safety tests.
Angle of wave attack = 90 deg

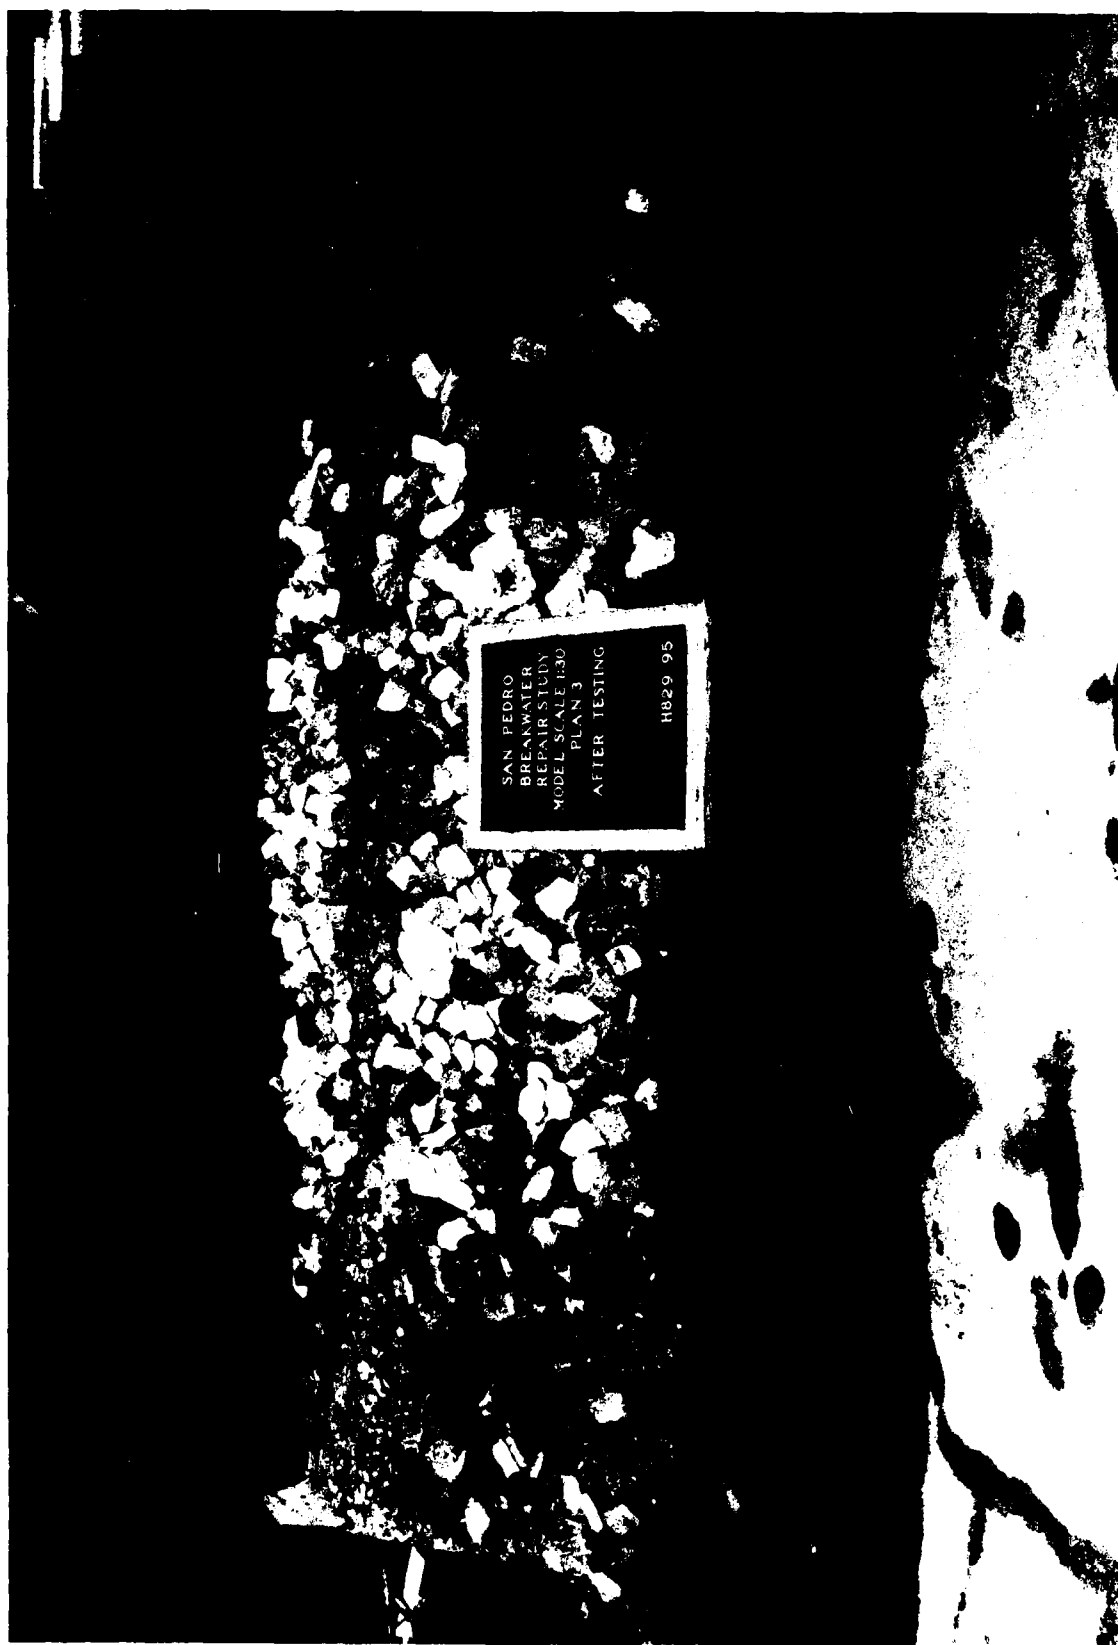
Photo 24. Harbor-side view of Plan 3 after factor of safety tests.
Angle of wave attack = 90 deg

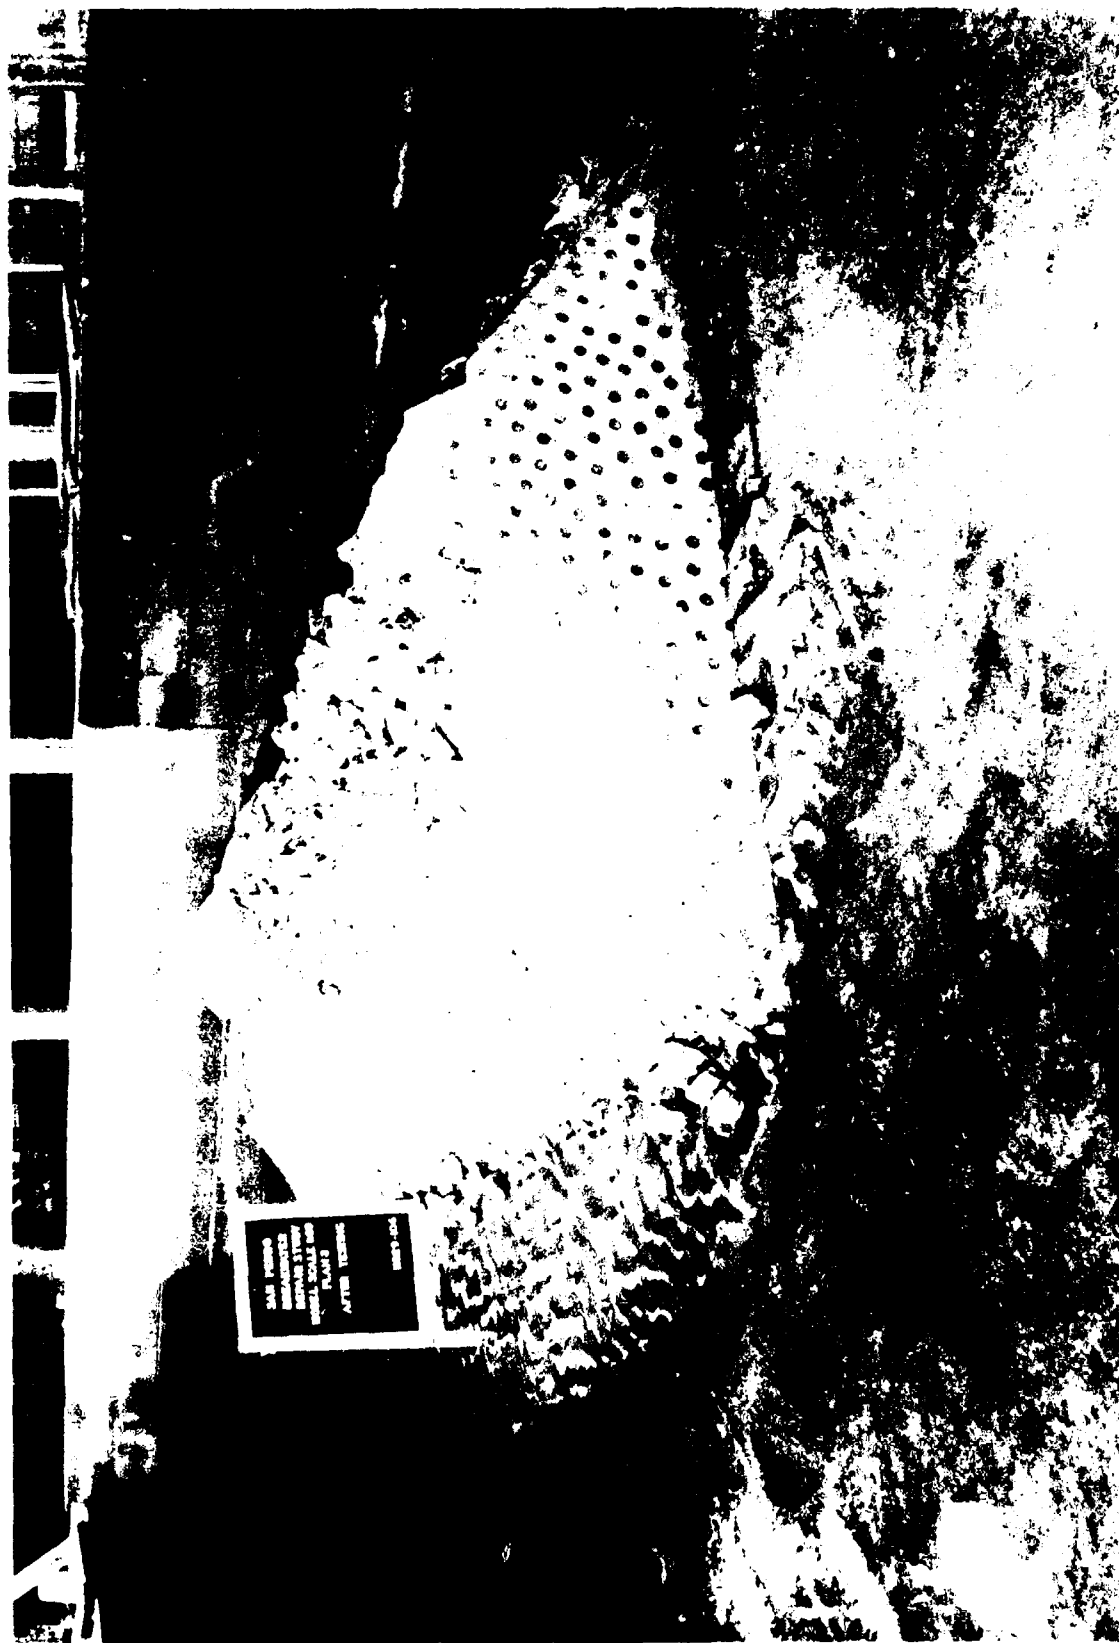
Photo 25. Sea-side view of Plan 3 after factor of safety tests.
Angle of wave attack = 45 deg

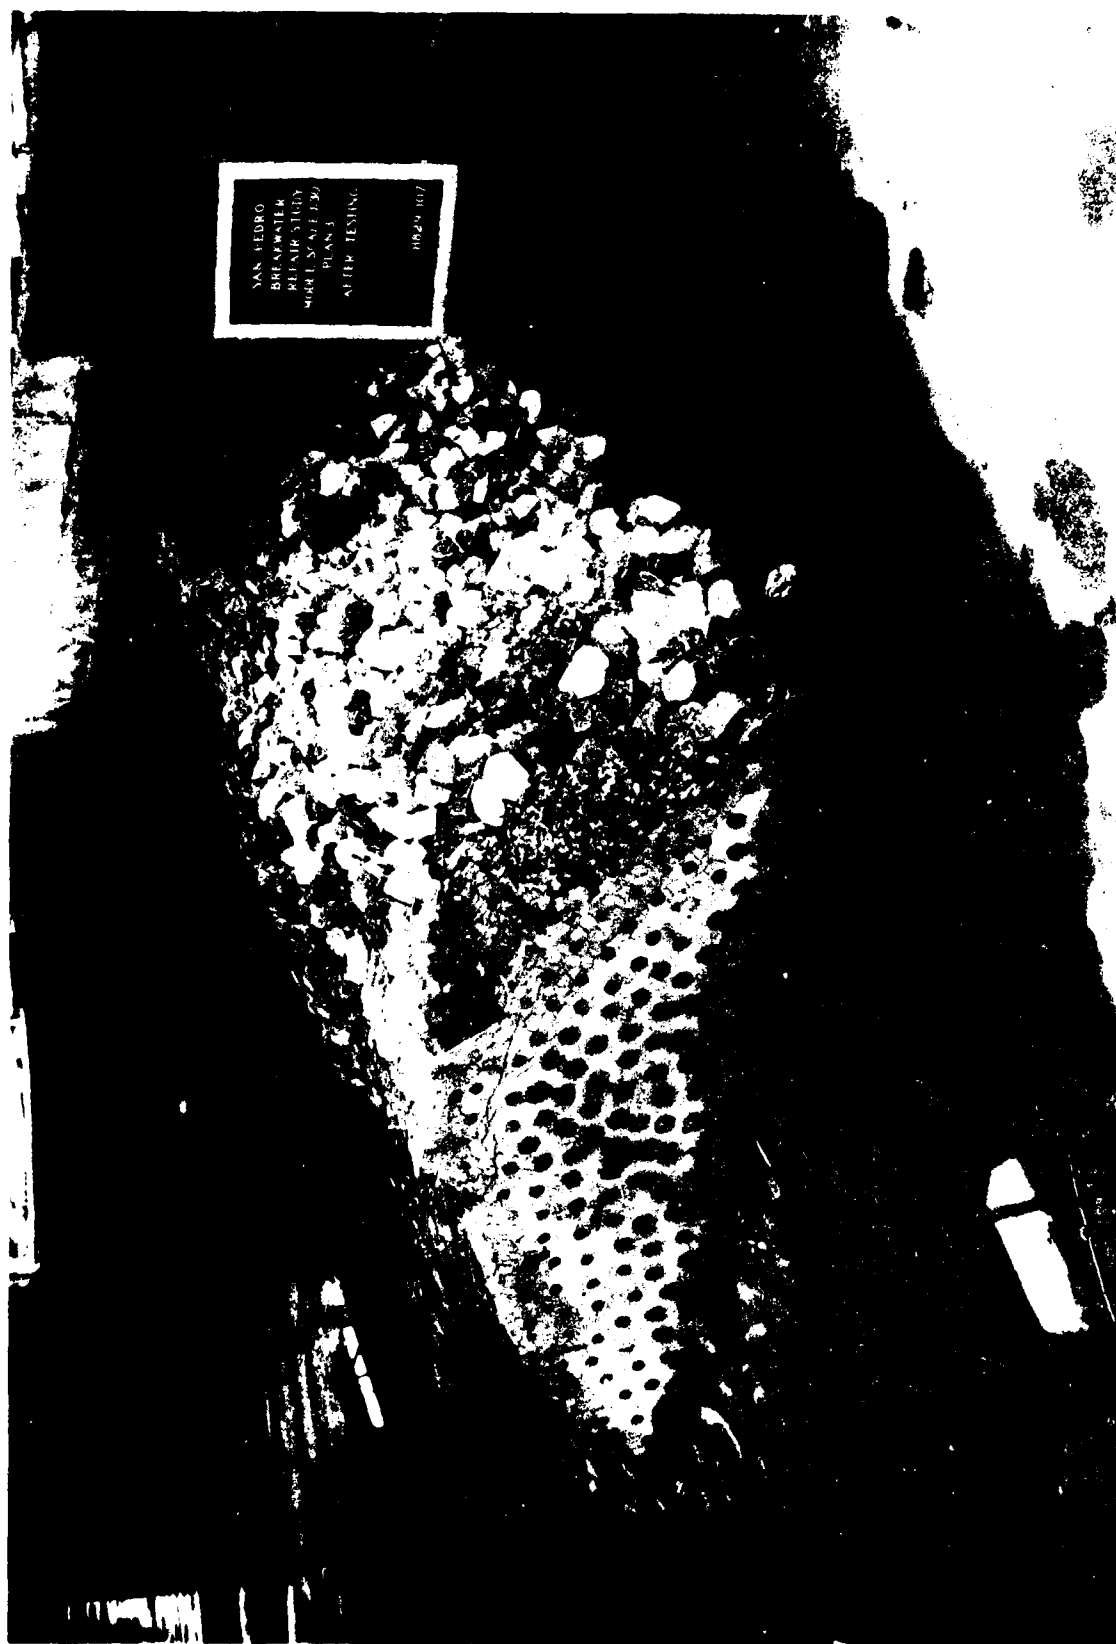
Photo 26. Harbor-side view of Plan 3 after factor of safety tests.
Angle of wave attack = 45 deg

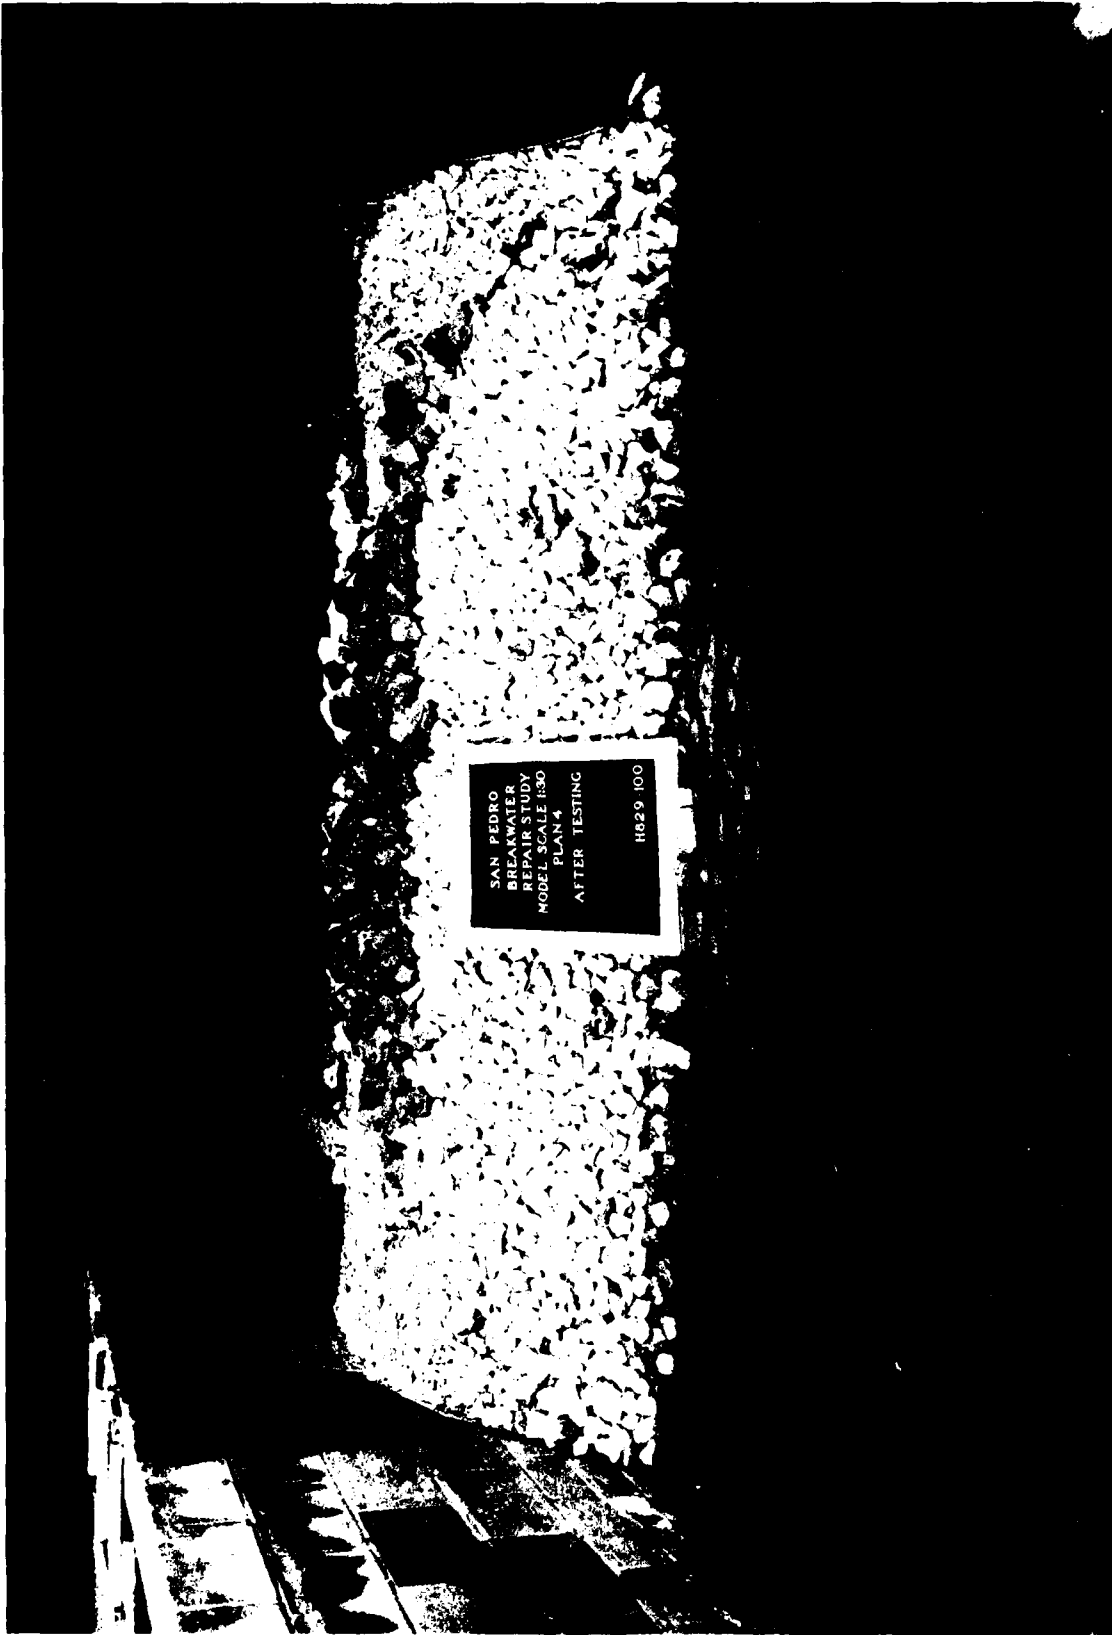
22. Plan 4 (Plates 7 and 8) was tested to determine its margin of safety from wave direction 1. Safety factor tests were initiated as an extension of Hydrograph B. Results of the tests were similar to those for Plan 3 from wave direction 1. Damage was concentrated in two areas, near the transitions and the harbor side of the repair with most of the damage caused by overtopping. Original granite blocks had been displaced during Hydrograph B, leaving the stone in the transition areas without support and vulnerable to wave attack during the safety factor tests.

23. Results of safety factor tests (Photos 27 and 28) show Plan 4 has sufficient resiliency to withstand waves in excess of design height without experiencing complete failure and confirms the conclusion from previous tests that Plan 4 exhibits a response similar to but slightly less than Plan 3 for wave direction 1.

Photo 27. Sea-side view of Plan 4 after factor of safety tests.
Angle of wave attack = 90 deg

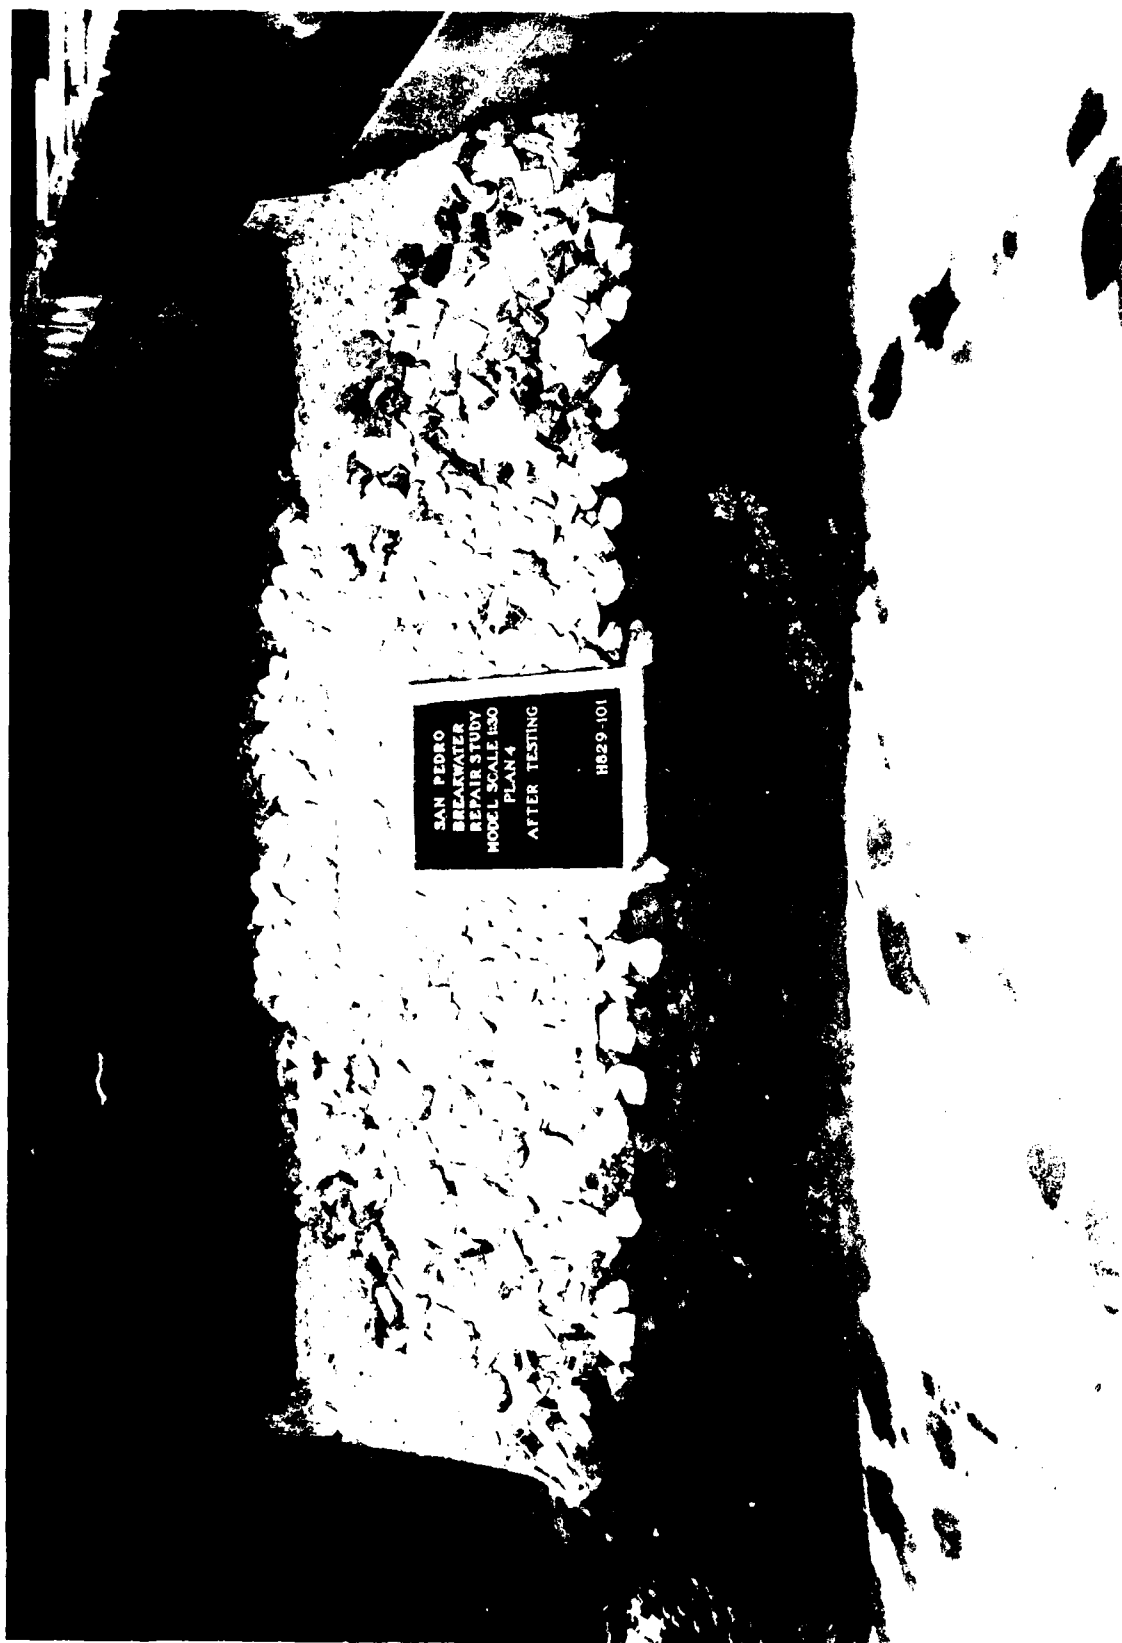
Photo 28. Harbor-side view of Plan 4 after factor of safety tests.
Angle of wave attack = 90 deg
